PVC and CPVC Tru-Bloc® True Union Vented (Bleach) Ball Valve, Model D

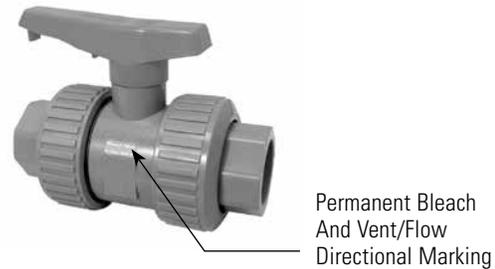
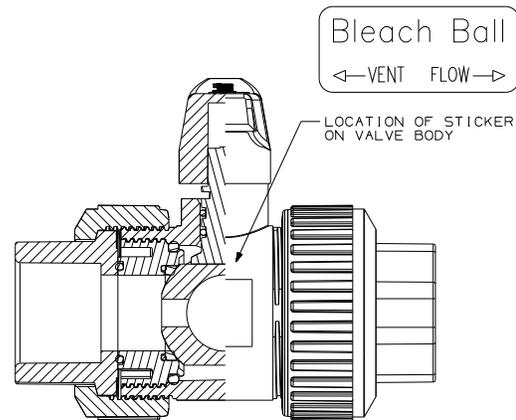
The Vented Ball Valve is a special factory modification to a PVC or CPVC True Union Ball Valve that effectively vents sodium hypochlorite out-gassing to the pressure port. In addition, the inner valve surfaces are kept constantly wetted to ensure problem-free use of the ball valves in bleach transfer and injection applications.

The Chemtrol® Vented Ball Valve offers a viable solution for sodium hypochlorite transfer and injection applications. Our unique factory-assembled bleach ball valve has effectively eliminated the problems associated with these uses. By ensuring that all inner surfaces of the valve are kept constantly wetted and vented to the upstream side when the valve is in the closed position, we have eliminated the conditions required for gas accumulation and caustic crystallization in the body cavity.
